Massive pleural effusion following central venous catheter migration: tips to remember.

Delayed catheter migration into the pleural space possibly due to erosion of vessel leading to massive pleural effusion in a one and a half year old child with 32% burns.

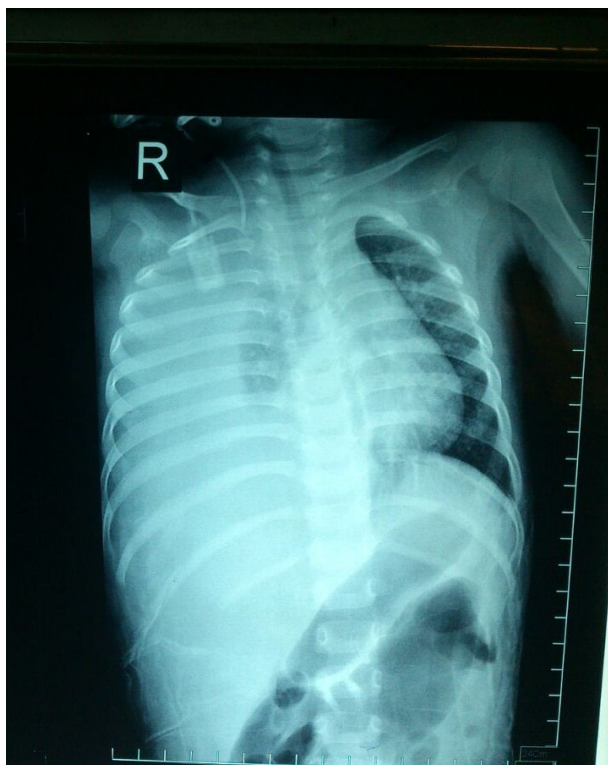
On the second day post procedure, patient developed tachypnea, for which chest X ray was done which showed right sided massive pleural effusion with mediastinal shift (Figure 1). Serous fluid was aspirated through one of the ports of CVC and other two were negative for aspiration of blood.

Figure 1. Chest X ray 48 hours after central line insertion

Approximately 180 ml of serosanguinous pleural fluid was drained under USG guidance following which there was clinical and radiological improvement (Figure 2). The CVC was removed and adhesive pressure dressing applied. The pleural fluid report showed red blood cells 96500/cu.mm, WBCs 640/cu.mm and sugar 123mg/dl which confirms presence of blood in the fluid.

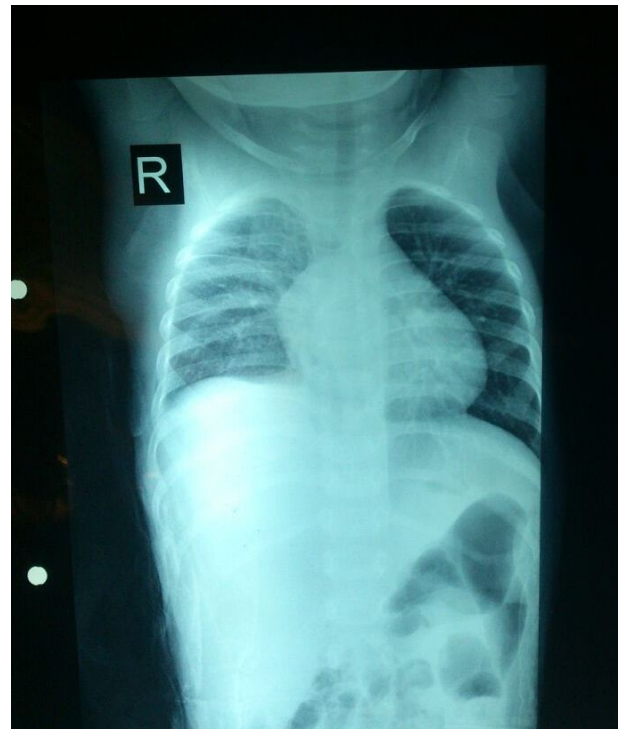
Figure 2. Chest X ray after drainage of pleural effusion.
